January 19, 2015

Re: Lucas Valley HOA Community Center, Structural Assessment
Job Address: 1201 Idylberry Road, San Rafael CA

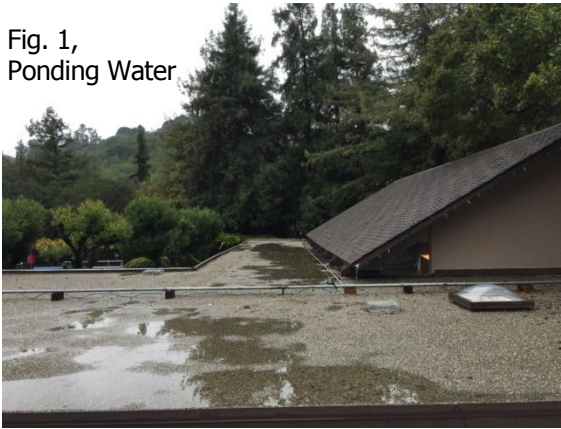
1. The Roof systems appeared to be in good serviceable condition, with no significant signs of distress. As expected, some weathering damage, including splitting at the end of wooden beams, has occurred (Figure 2). Rain water ponding was noted on the flat roofs, indicating some amount of framing member sag (Figure 1).

Fig. 1,
Ponding Water

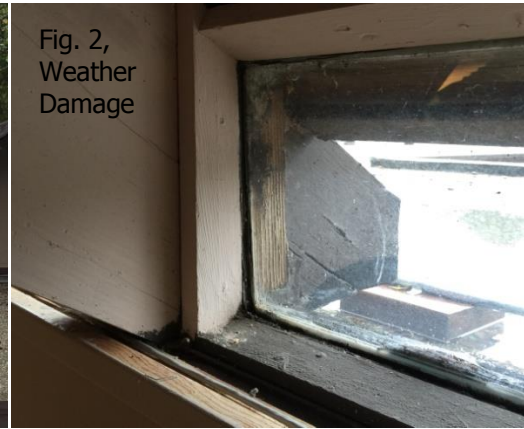
Fig. 2,
Weather
Damage

- The lack of any hardware between the 4x10 rafters and top plates, with no blocking except the clearstory windows, is a substandard connection detail (Figure 2 & 5).
- The perimeter wall mudsill anchor bolting to the concrete footing is likely inadequate.

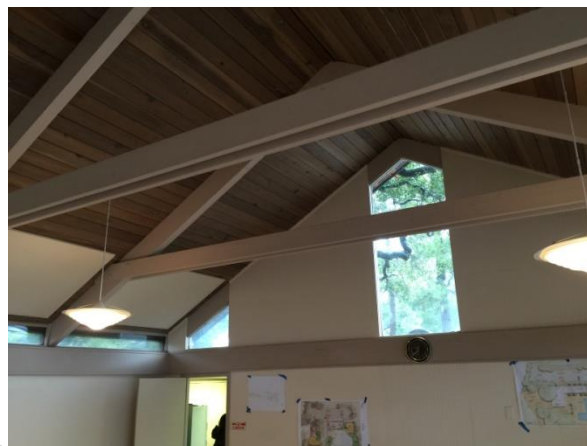
2. The pitched roof structure is constructed of site-built trusses, consisting of 4x10 beams collar-tied with (2) 2x8's. The 2x8's appear to be bolted to the 4x10 beam with (2) 5/8" diameter bolts (Figure 3). This connection is likely substandard, although it appears to be performing adequately.

Fig. 3, Trusses

3. The roof system diaphragm is constructed of 2x6 t&g. Considering the dimensions of the Great Room, this diaphragm is likely overstressed in shear (Figure 3).

Many of the items noted above could be rectified or improved upon substantially fairly simply. Of greatest concern is the connection of the CMU walls to the roof, the clearstory windows. Unfortunately, retrofitting these shortcomings could affect the Eichler character of the structure. The Gathering Building could be fairly easily strengthened during future remodeling and maintenance; shear walls, anchor bolting and reinforcement of the truss connections. The roof diaphragm could be sheathed with plywood while re-roofing, strengthening it.

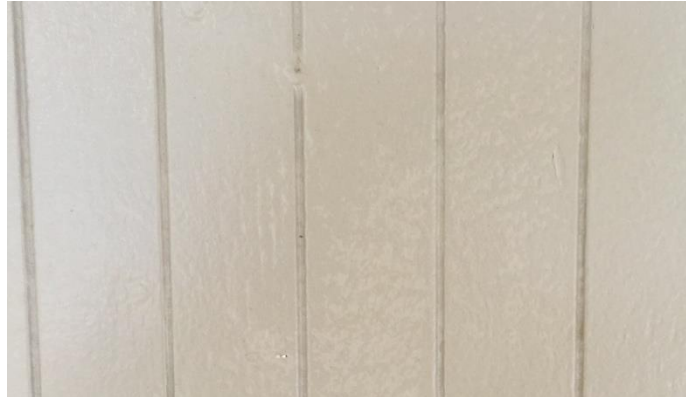
- The exterior shear walls derive their strength from T1-11 siding, which is not considered a reliable shear wall sheathing. Therefore, the shear walls are likely overstressed.

Fig. 4, T1-11 Siding

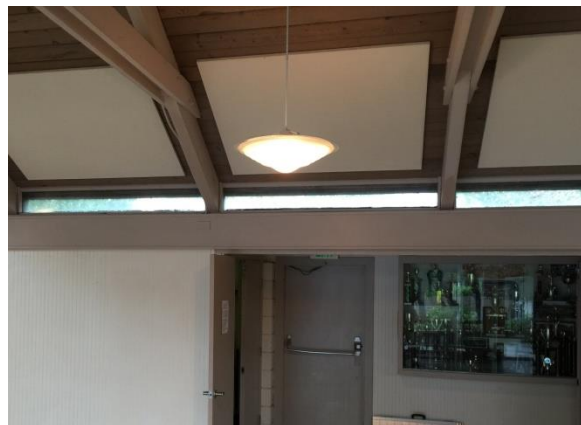
- The perimeter of the pitched roof sheds down to the T1-11 clad shear walls, but the roof shear transfer is compromised by the clear story glass windows. All roof shear demands are expected to transfer through the 4x10 rafter beam connection to wall top plates through cross grain bending "twisting" of the beam (Figure 5).

Fig. 5, Clear Story Windows

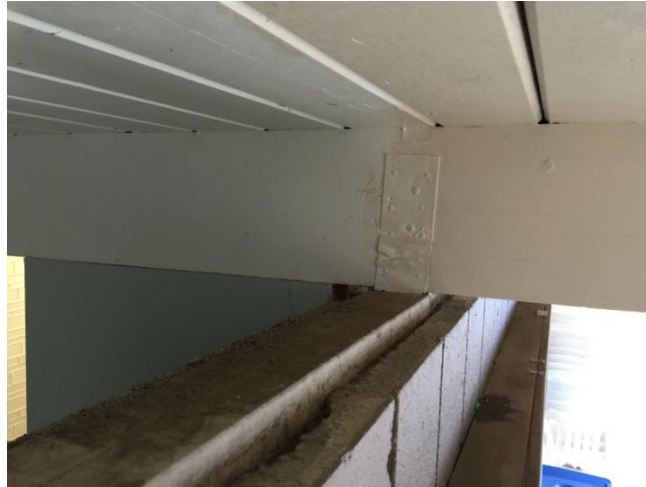
1. The perimeter walls are CMU block, assumed to be reinforced and fully grouted. These masonry walls provide tremendous strength, but the roof structure is not adequately connected to the CMU walls, and could separate in a significant seismic event. The "in-plane" strength is significantly reduced due to the clear-story openings, and the "out-of-plane" strap connection is not capable of resisting the required demand (Figure 6).

Fig. 6, Out of Plane and Clear Story Opening

2. The "out-of-plane" CMU wall transfers significant loads into the roof system diaphragm and, since the roof diaphragms are constructed of 2x6 t&g decking, and the transverse partition walls are not of adequate strength to reduce roof diaphragm loads, the roof diaphragm is likely overstressed (Figure 6).
