January 19, 2015

Re: Lucas Valley HOA Community Center, Structural Assessment
Job Address: 1201 Idylberry Road, San Rafael CA

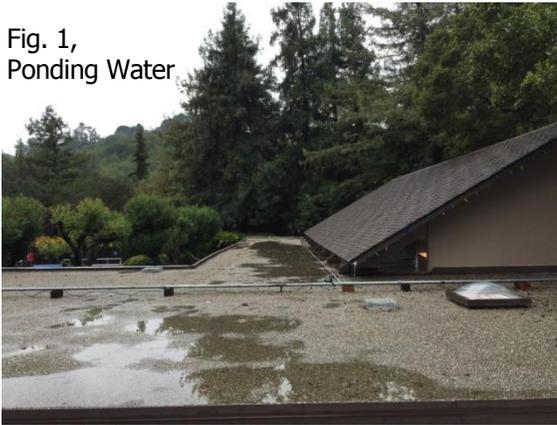
Fig. 1,
Ponding Water

1. The Roof systems appeared to be in good serviceable condition, with no significant signs of distress. As expected, some weathering damage, including splitting at the end of wooden beams, has occurred (Figure 2). Rain water ponding was noted on the flat roofs, indicating some amount of framing member sag (Figure 1).

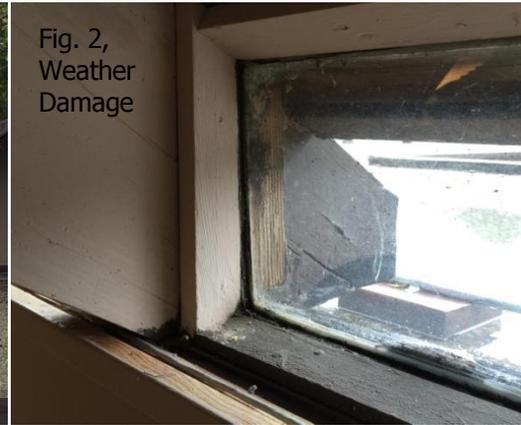
Fig. 2,
Weather
Damage

- The lack of any hardware between the 4x10 rafters and top plates, with no blocking except the clearstory windows, is a substandard connection detail (Figure 2 & 5).
- The perimeter wall mudsill anchor bolting to the concrete footing is likely inadequate.

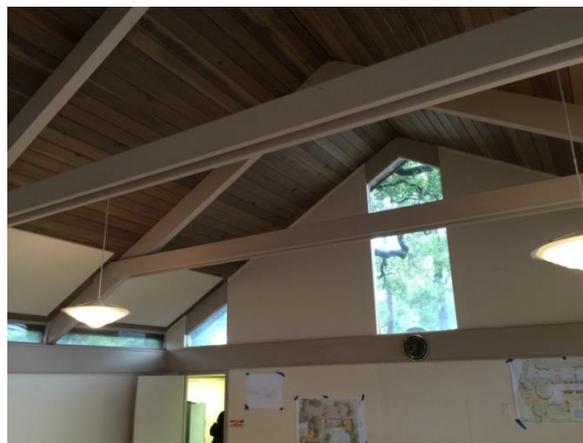
Fig. 3, Trusses

2. The pitched roof structure is constructed of site-built trusses, consisting of 4x10 beams collar-tied with (2) 2x8's. The 2x8's appear to be bolted to the 4x10 beam with (2) 5/8" diameter bolts (Figure 3). This connection is likely substandard, although it appears to be performing adequately.

3. The roof system diaphragm is constructed of 2x6 t&g. Considering the dimensions of the Great Room, this diaphragm is likely overstressed in shear (Figure 3).

Many of the items noted above could be rectified or improved upon substantially fairly simply. Of greatest concern is the connection of the CMU walls to the roof, the clearstory windows. Unfortunately, retrofitting these shortcomings could affect the Eichler character of the structure. The Gathering Building could be fairly easily strengthened during future remodeling and maintenance; shear walls, anchor bolting and reinforcement of the truss connections. The roof diaphragm could be sheathed with plywood while re-roofing, strengthening it.

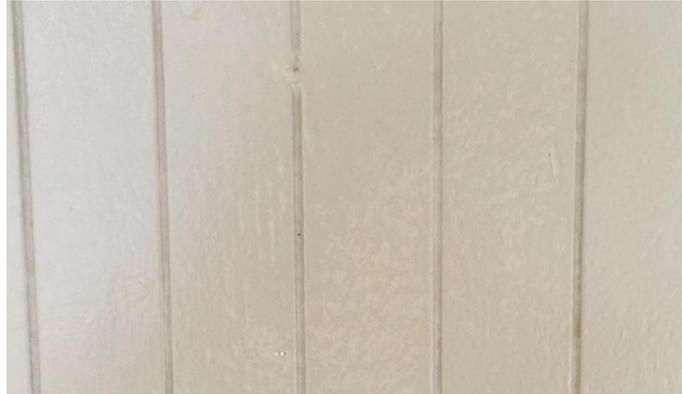
Fig. 4, T1-11 Siding

- The exterior shear walls derive their strength from T1-11 siding, which is not considered a reliable shear wall sheathing. Therefore, the shear walls are likely overstressed.

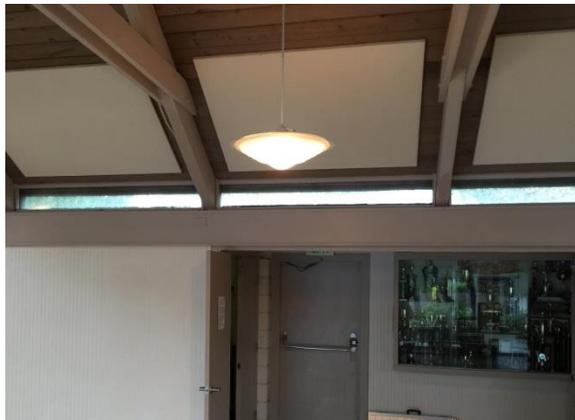
Fig. 5, Clear Story Windows

- The perimeter of the pitched roof sheds down to the T1-11 clad shear walls, but the roof shear transfer is compromised by the clear story glass windows. All roof shear demands are expected to transfer through the 4x10 rafter beam connection to wall top plates through cross grain bending "twisting" of the beam (Figure 5).

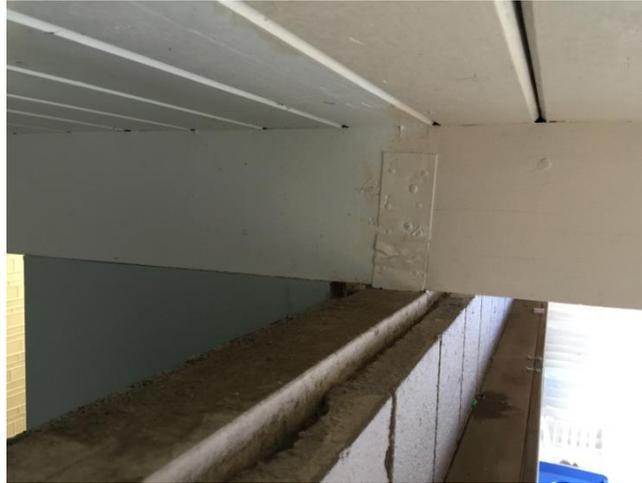
Fig. 6, Out of Plane and Clear Story Opening

1. The perimeter walls are CMU block, assumed to be reinforced and fully grouted. These masonry walls provide tremendous strength, but the roof structure is not adequately connected to the CMU walls, and could separate in a significant seismic event. The "in-plane" strength is significantly reduced due to the clear-story openings, and the "out-of-plane" strap connection is not capable of resisting the required demand (Figure 6).

2. The "out-of-plane" CMU wall transfers significant loads into the roof system diaphragm and, since the roof diaphragms are constructed of 2x6 t&g decking, and the transverse partition walls are not of adequate strength to reduce roof diaphragm loads, the roof diaphragm is likely overstressed (Figure 6).
